Butterfly valves - How to estimate cavitation level and related damage on existing locks and at the laboratory?

C. Savary¹ & M. Minet²

¹Hydraulic Research Laboratory, Service public de Wallonie, Châtelet, Belgium

Abstract: The butterfly valves (3.5m diameter) of the new lock of Lanaye (Albert canal Belgium) are subject to cavitation during the filling/emptying of the lock. On site measurements were realized to characterize the cavitation and to optimize valves operation in order to decrease the intensity and duration of cavitation. For comparison, measurements were realized in an existing lock with similar valves which also experience cavitation but without associated damage since 1960. The duration of cavitation is more or less the same for both locks, but the cavitation intensity is more important in Lanaye. To check the appearance of eventual damages, annual monitoring of the valves is realized. Small damage was observed but the link with cavitation is not obvious. In parallel, at the laboratory, the efficiency of aeration provided around the valve was tested for different configurations. The sound and vibrations due to cavitation are reduced when aeration is provided. Tests

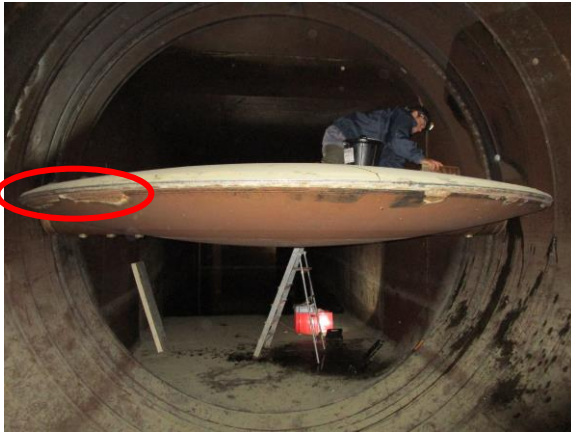
Figure 4. Global view from upstream of the downstream valve

The monitoring has been realized twice (2016 and 2017). In general, the degradations are not important. At some places, the protecting paint was removed and corrosion was observed. The damaged areas are mainly at the discontinuities like soldered joints in the culverts and at the periphery of the body of the valve (Figure 4, indicated in red), expansion waves and articulations. The border of the body of the valve, made of stainless steel is not damaged, ensuring good water tightness. Two areas located downstream of the valve in the upper part of the culvert are particularly damaged even if they don't present discontinuity (Figure 5). One of the valves is more degraded than the other despite the identical solicitation. It is assumed to be linked to the variation in the manufacturing or building conditions (e.g. painting adherence).

It is difficult to determine if the damages are linked to cavitation or are only due to the important velocity and abrasion due to the presence of sediments in the flow. Some of the damages are located upstream of the valve, at places which are not submitted to cavitation. Moreover, the damages don't present pitting patterns characteristics of cavitation. As

No new damage appeared between 2016 and 2017, but the existing damaged areas enlarged. It was decided to maintain the rhythm of annual inspections.

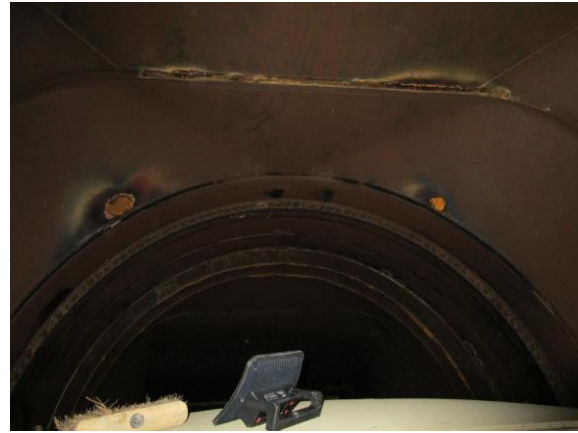
Figure 5. Damages located downstream of the valve in the upper part of the culvert

highlighted the location of critical areas. The damages are concentrated on the top of the pipe in the downstream neighboring of the valve, which corresponds to observations on site (Figure 5).

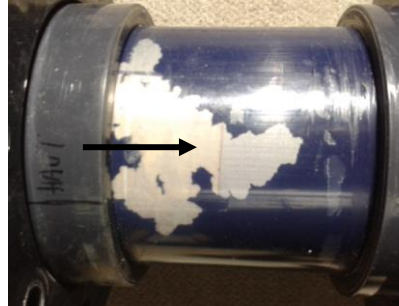
- The inside of the pipe was painted black (Figure 18). The idea was that the paint would be removed preferentially in areas subject to cavitation. For all the tested flow (intense cavitation with and without aeration), the paint on the upper part of the pipe was removed. At the opposite of expectations, no difference was noticed with or without aeration; the removal of the paint was probably linked to the high velocity of the flow and its trajectory. Another drawback was that the extension with time of the damaged area was variable and not reproducible (probably due to variation in the application of the paint).

Figure 18. Black paint – view from above of the degraded area

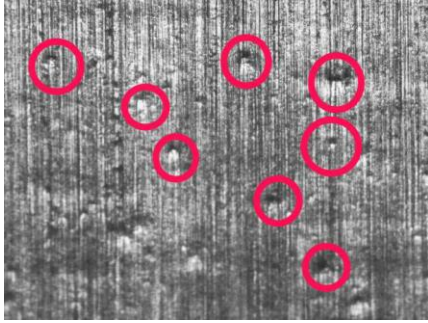
The first test (Test 1 Table 1) was stopped after 60h, deep pits due to cavitation were observed, but the density was not important. It was decided to increase the duration of the tests to 160h for an easier analysis with the microscope. Figure 20 is the picture of the Aluminum sheet magnified by the microscope (2.5x1.9 mm in reality) in the most damaged area for intense cavitation (Test 2 in Table 1). Some of the deep pits are surrounded with red circles. The most damaged areas are located on the upper part of the pipe (+/- 30° from the upper generating line of the pipe) in the downstream neighboring of the valve (0 to 15 cm downstream of the valve). They are approximately delimited on Figure 21, the location corresponding to Figure 20 is also indicated by the red point.

Figure 20. Pits due to cavitation – Test 2

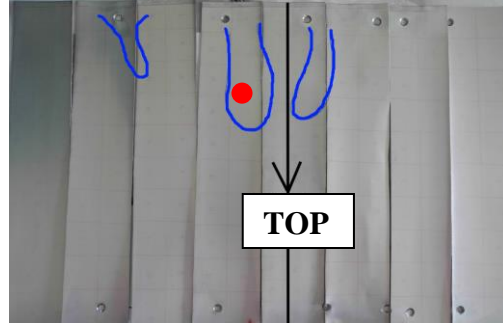
Figure 21. Most damaged areas – Test 2

In condition of intense cavitation, after 160h (Tests 2 and 5), in the most damaged area around 250 pits per cm² were manually counted. The results obtained for Tests 2 and 5 were similar, indicating a good reproducibility of the experiments. The only difference between the two tests was the initial surface treatment of the Aluminum sheet. For Test 5, half of the Aluminum sheet was manually polished in order to suppress the stripes due to the manufacturing visible at the microscope. Figure 22 is the equivalent of Figure 20 but for Test 5, with an initial polished surface. The damage is easier to detect when the surface is polished. In order to compare, Figures 23 and 24 are pictures of an area without cavitation, respectively, for polished and not polished Aluminum.

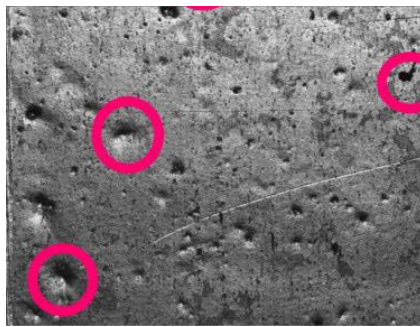
Figure 22. Pits due to cavitation – Test 5 – polished Aluminum

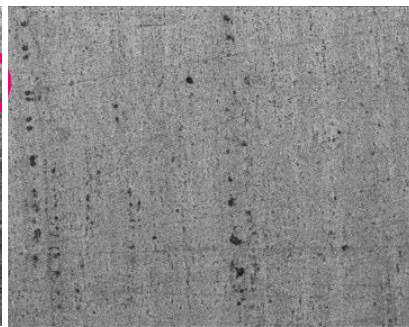
Figure 23. Not damaged areas – Test 5 – polished Aluminum

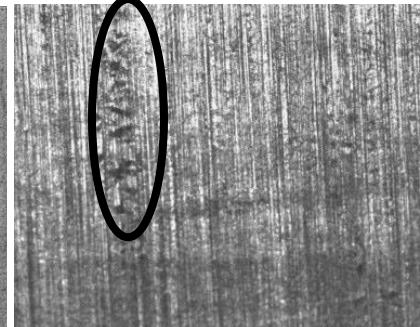
Figure 24. Not damaged areas – not polished Aluminum – Test 4 (equivalent to Tests 3 and 6)

Figure 24 corresponds to intense cavitation with aeration (the location of the pictured area is the same for Figures 20, 22 and 24). No deep pits are observed. The picture is the same than the one obtained for a flow without cavitation (Test 6). The marks like the one highlighted in Figure 24 are not due to cavitation; they are also present for a flow without cavitation. If the surface is polished before the test, these marks disappear. For Test 3, for an incipient damage level of cavitation, no pitting was observed on the Aluminum sheet downstream of the valve; Figure 24 is representative for all areas.
